**Flood Control Project Maintenance
Levee Inspections****LMA District Cover Sheet****Spring 2013 Levee Inspection Results****Reclamation District No. 2101 Blewett**

Levee Inspection Report By Mile - Spring 2013

Reclamation District No. 2101 Blewett

Waterway				Bank	Unit Miles	Inspection Start/End	Inspector	
Unit No. 01 San Joaquin River				Left	3.20	05/07/2013 05/07/2013	Maksim Khashchuk

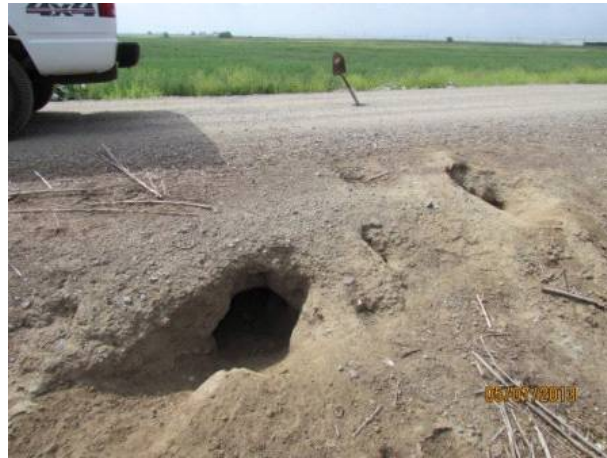
Levee Mile Report Line	5
Start Levee Mile	0.04
End Levee Mile	0.04
Location	Water Side
Category	
Item	Animal Control
View of rodent holes on waterward slope, facing upstream.	
mkhashch_s_20130509_729.JPG

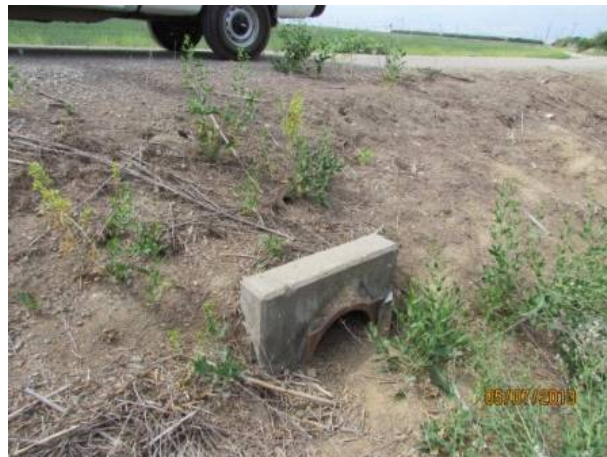
Levee Mile Report Line	6
Start Levee Mile	0.05
End Levee Mile	0.05
Location	Water Side
Category	
Item	Encroachments
View of the pipe penetrating the levee. No flap gate at waterside end was observed.	
mkhashch_s_20130509_730.JPG

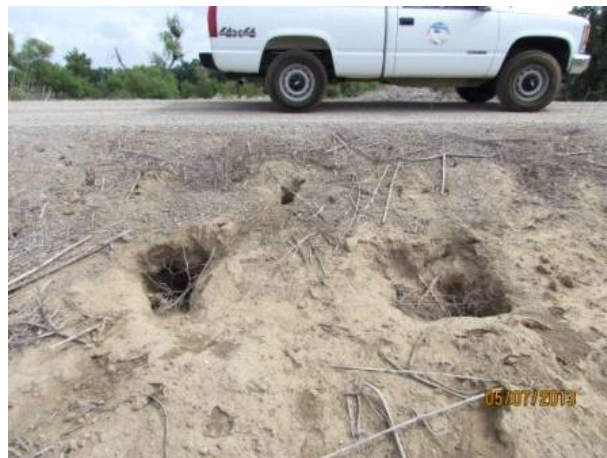
Levee Mile Report Line	8
Start Levee Mile	0.07
End Levee Mile	0.07
Location	Land Side
Category	
Item	Animal Control
View of rodent burrows on the landside levee slope.	
mkhashch_s_20130509_731.JPG

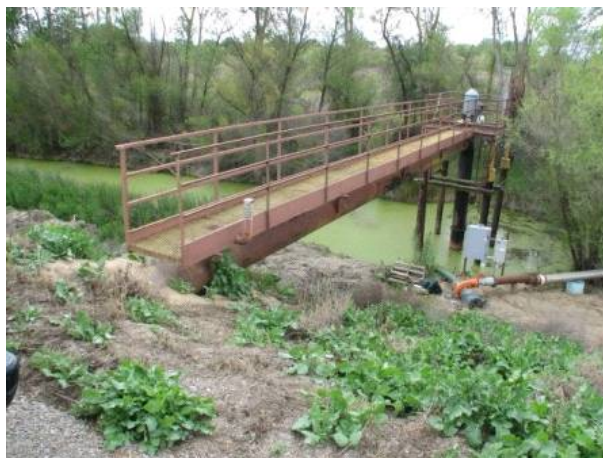
Levee Mile Report Line	10
Start Levee Mile	0.19
End Levee Mile	0.19
Location	Crown
Category	
Item	Encroachments

Drainage discharge under levee crown.

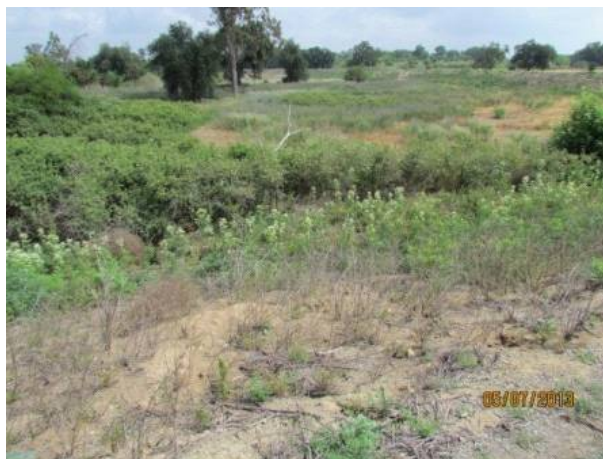
Levee Mile Report Line	13
Start Levee Mile	0.70
End Levee Mile	0.70
Location	Water Side
Category	
Item	Animal Control

View of the rodent burrows on the waterside levee slope.

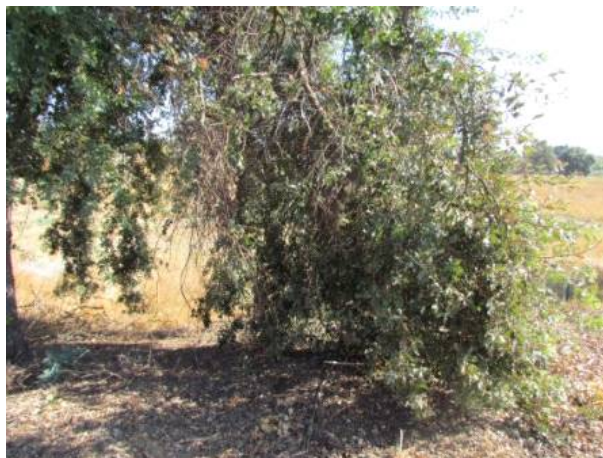
Levee Mile Report Line	15
Start Levee Mile	0.75
End Levee Mile	0.75
Location	Water Side
Category	
Item	Trim / Thin Trees

View of tree branches obstructing waterside slope.

LMR No.	Levee Mile		Category	Item	Location * + Rating	Action/Comment	GPS Latitude/Longitude		Issue No. Photo
	Start	End					Start	End	
15	0.75	0.75		Trim / Thin Trees	WS Ma	T1 : Trim trees to at least five feet above ground level. Inspector Comments: Trim tree to allow access and visibility.	37.659705 ° -121.243306 °	37.659705 ° -121.243306 °	11 Y
DWR ID: DWR_RD2101_01_f_2012_11									
16	0.76	1.80		Encroachments	LS En	DT : Ditch	37.659827 ° -121.243675 °	37.651049 ° -121.231475 °	944 Y
DWR ID: DWR_RD2101_01_s_2012_944									
17	0.80	0.80		Animal Control	LS Ma	A1 : Exterminate rodents and backfill and compact or grout burrows.	37.659302 ° -121.242875 °	37.659302 ° -121.242875 °	22 Y
DWR ID: DWR_RD2101_01_s_2012_22									
18	0.88	0.88		Animal Control	LS Ma	A3 : No rodents visible, but rodent burrows visible; need to backfill and compact or grout burrows.	37.658663 ° -121.241750 °	37.658663 ° -121.241750 °	3 Y

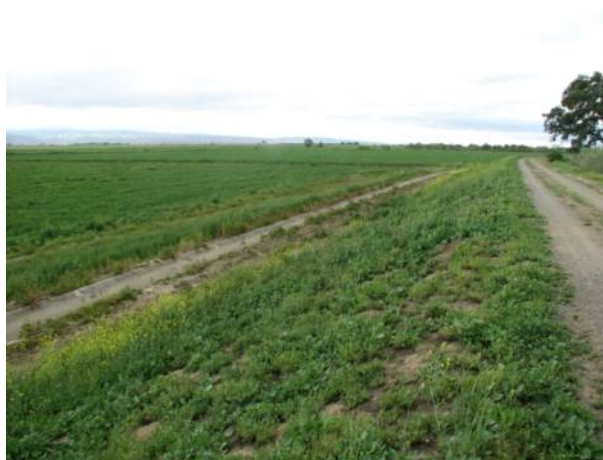
Levee Mile Report Line	16
Start Levee Mile	0.76
End Levee Mile	1.80
Location	Land Side
Category	
Item	Encroachments

Concrete ditch near landside toe.

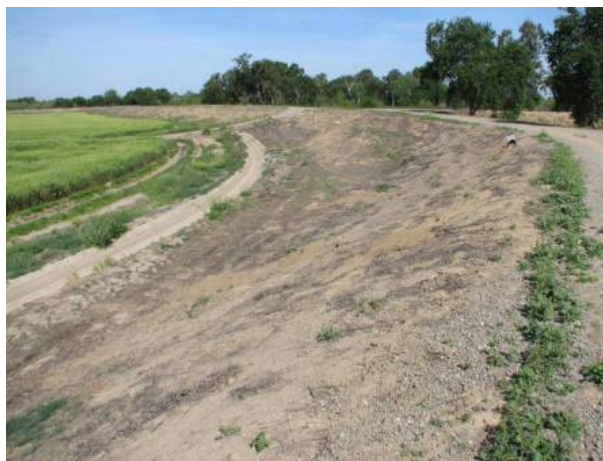
Levee Mile Report Line	17
Start Levee Mile	0.80
End Levee Mile	0.80
Location	Land Side
Category	
Item	Animal Control

View of levee material removed by rodent activity on landside slope facing downstream. 05/02/2012

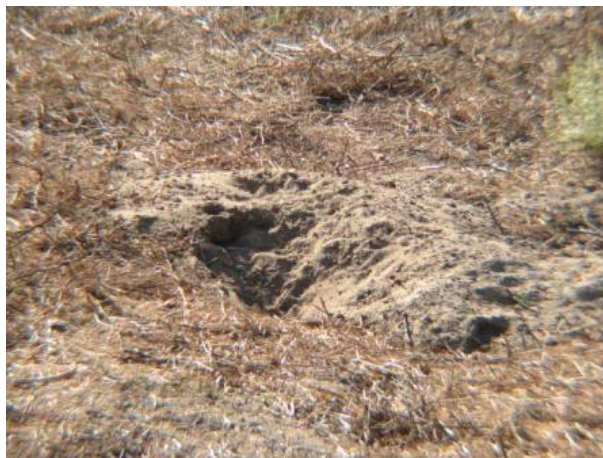
Levee Mile Report Line	18
Start Levee Mile	0.88
End Levee Mile	0.88
Location	Land Side
Category	
Item	Animal Control

11/02/2011 Active rodent burrow.

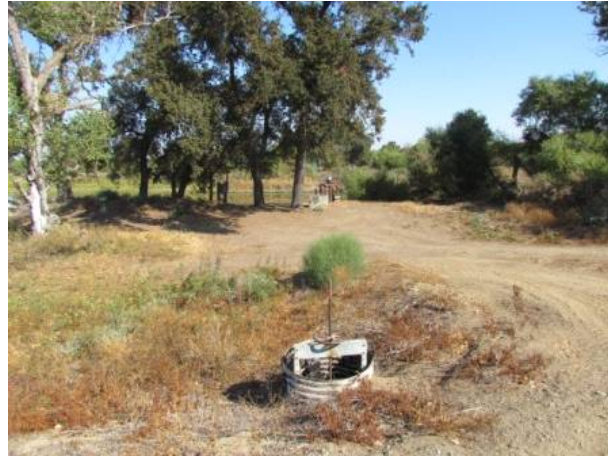
Levee Mile Report Line	20
Start Levee Mile	1.61
End Levee Mile	1.61
Location	Water Side
Category	
Item	Encroachments

Photo of pump in background and CMP riser with valve in foreground.

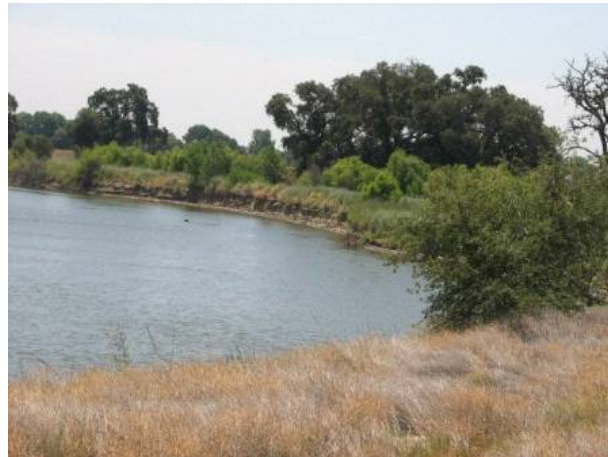
Levee Mile Report Line	22
Start Levee Mile	1.91
End Levee Mile	2.00
Location	Water Side
Category	Supplemental
Item	DWR Erosion Survey

Looking downstream from levee top. The tree at the water edge is the visible starting point of the erosion.

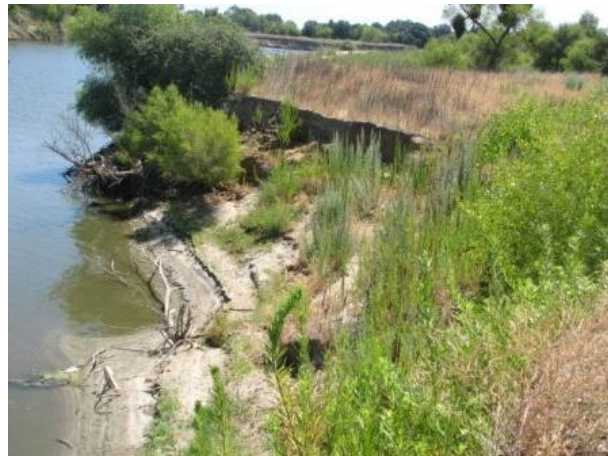
Levee Mile Report Line	22
Start Levee Mile	1.91
End Levee Mile	2.00
Location	Water Side
Category	Supplemental
Item	DWR Erosion Survey

A close look at the erosion.

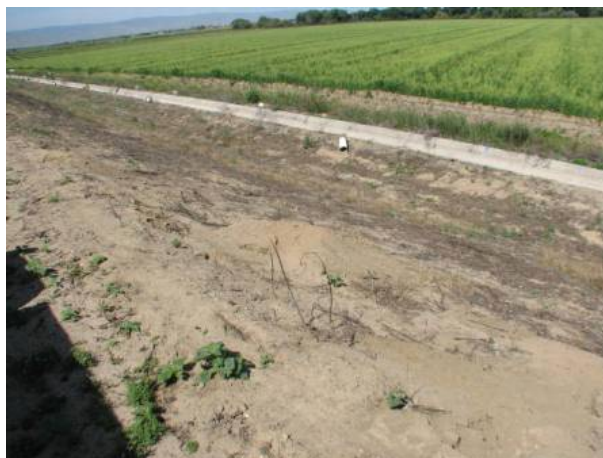
Levee Mile Report Line	23
Start Levee Mile	2.39
End Levee Mile	2.39
Location	Land Side
Category	
Item	Animal Control

LMIR No.	Levee Mile		Category	Item	Location * + Rating	Action/Comment	GPS Latitude/Longitude		Issue No.
	Start	End					Start	End	Photo
23	2.39	2.39		Animal Control	LS Ma	A1 : Exterminate rodents and backfill and compact or grout burrows.	37.645785 ° -121.226337 °	37.645785 ° -121.226337 °	30 Y
DWR ID: DWR_RD2101_01_s_2012_30									
24	2.74	2.74		Encroachments	WS En	PI : Pipe	37.642005 ° -121.229742 °	37.642005 ° -121.229742 °	21 Y
DWR ID: DWR_RD2101_01_s_2012_21									
25	2.88	2.88		Animal Control	WS Ma	A3 : No rodents visible, but rodent burrows visible; need to backfill and compact or grout burrows. Inspector Comments: Active burrows with squirrels observed. Burrows on both sides of levee.	37.640305 ° -121.230095 °	37.640305 ° -121.230095 °	27 Y
DWR ID: DWR_RD2101_01_s_2012_27									
26	2.89	2.89		Encroachments	WSA/W En	PI : Pipe	37.640133 ° -121.230037 °	37.640133 ° -121.230037 °	25 Y
DWR ID: DWR_RD2101_01_s_2012_25

View of levee material removed by rodent activity on landside slope, facing upstream. 05/02/2012

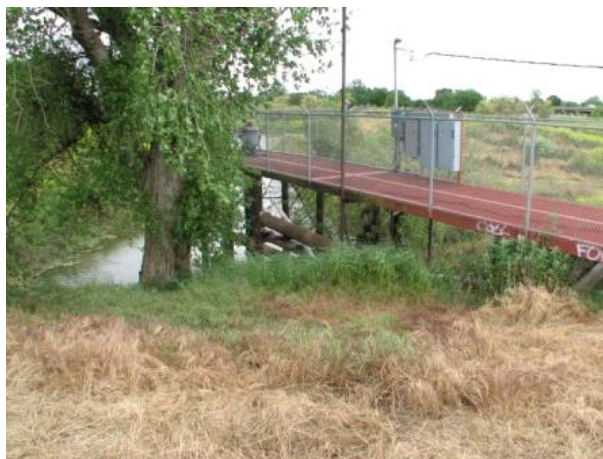
Levee Mile Report Line	24
Start Levee Mile	2.74
End Levee Mile	2.74
Location	Water Side
Category	
Item	Encroachments

Irrigation intake near Maze Blvd.

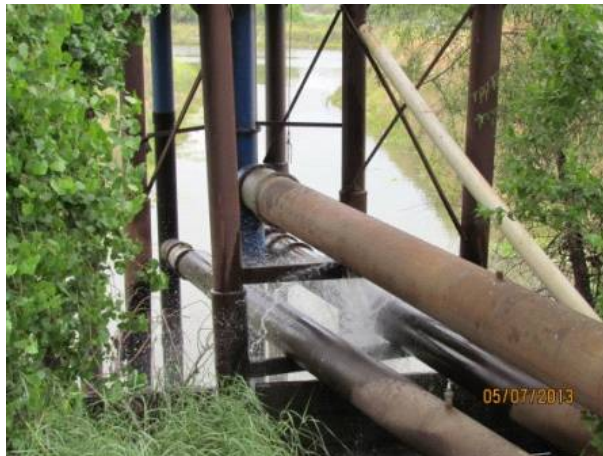
Levee Mile Report Line	24
Start Levee Mile	2.74
End Levee Mile	2.74
Location	Water Side
Category	
Item	Encroachments

View of the pipe leaking during pumping. May cause erosion at waterside levee toe.

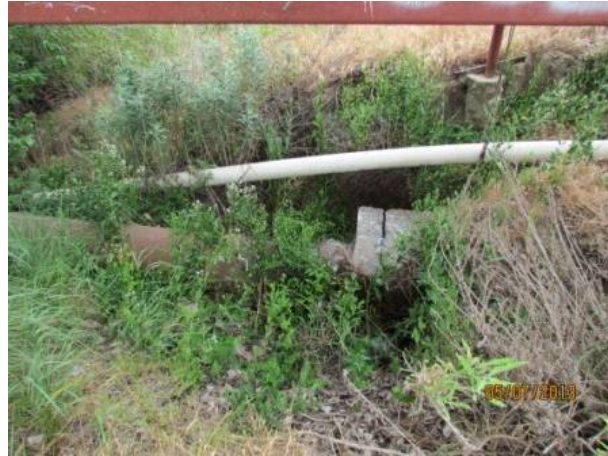
Levee Mile Report Line	24
Start Levee Mile	2.74
End Levee Mile	2.74
Location	Water Side
Category	
Item	Encroachments

View of the leaking connection penetrating the levee. May cause erosion of the waterside levee slope.

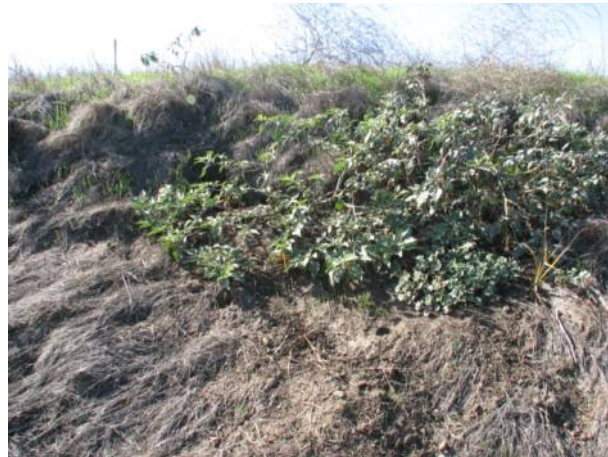
Levee Mile Report Line	25
Start Levee Mile	2.88
End Levee Mile	2.88
Location	Water Side
Category	
Item	Animal Control

Rodent holes on levee slope hidden by vegetation.

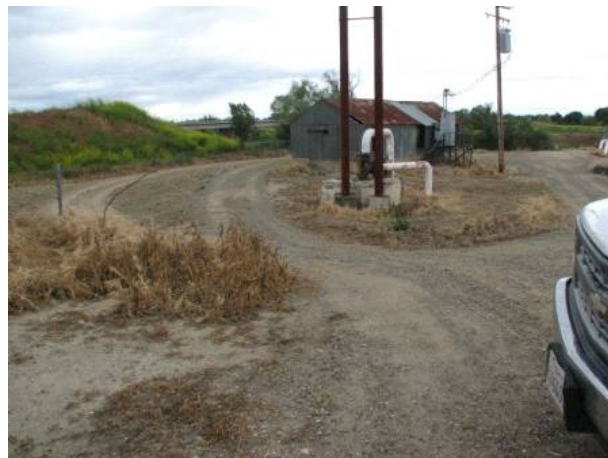
Levee Mile Report Line	26
Start Levee Mile	2.89
End Levee Mile	2.89
Location	Water Side
Category	
Item	Encroachments

Risers on waterside berm and risers along road leading to levee indicate presence of pipe penetration.

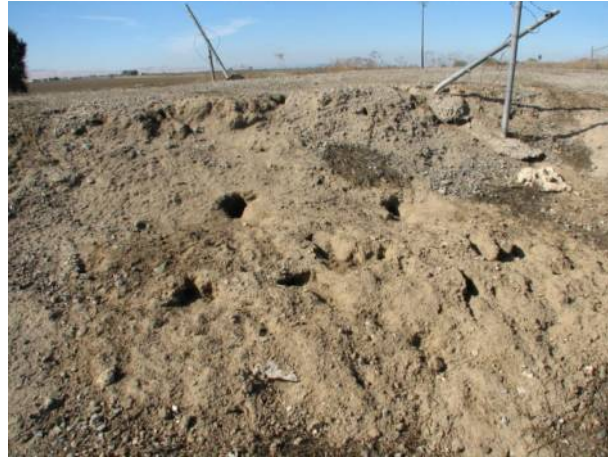
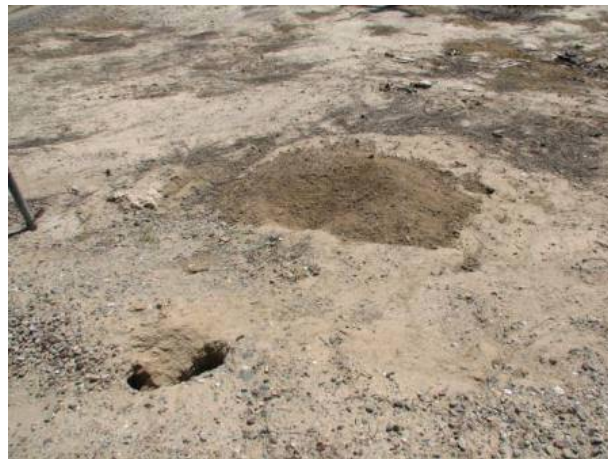
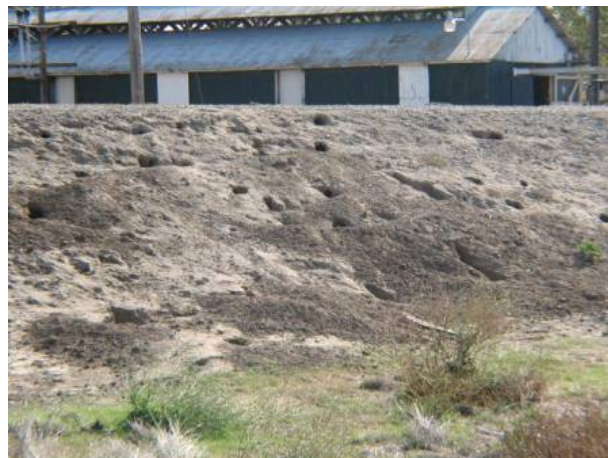
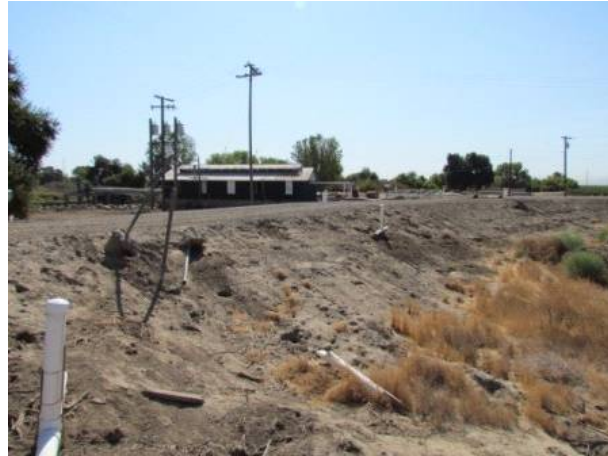
27	2.89	2.89		Animal Control	LS Ma	A3 : No rodents visible, but rodent burrows visible; need to backfill and compact or grout burrows. Inspector Comments: Numerous rodent holes throughout levee slope.	37.640134 ° -121.230019 °	37.640134 ° -121.230019 °	28 Y
DWR ID: DWR_RD2101_01_s_2012_28									
28	2.91	2.91		Erosion / Bank Caving	WS Ma	E2 : Schedule repair of erosion site prior to the next inspection.	37.639852 ° -121.229980 °	37.639852 ° -121.229980 °	29 Y
DWR ID: DWR_RD2101_01_s_2012_29									
29	2.91	2.91		Encroachments	WSA/W Ma	PI : Pipe Inspector Comments: Flap gates open.	37.639824 ° -121.230005 °	37.639824 ° -121.230005 °	24 Y
DWR ID: DWR_RD2101_01_s_2012_24									
30	3.02	3.20		Animal Control	LS Ma	A1 : Exterminate rodents and backfill and compact or grout burrows. Inspector Comments: Active burrows with rodents present.	37.638760 ° -121.231341 °	37.638760 ° -121.231341 °	17 Y
DWR ID: DWR_RD2101_01_s_2012_17

Levee Mile Report Line	27
Start Levee Mile	2.89
End Levee Mile	2.89
Location	Land Side
Category	
Item	Animal Control
Rodent holes on levee slope.	
mkhashch_s_20130225_618.jpg

Levee Mile Report Line	27
Start Levee Mile	2.89
End Levee Mile	2.89
Location	Land Side
Category	
Item	Animal Control
05/26/2011 Updated photo of animal control issue noted in Fall 2010 inspection, fresh rodent burrow present.	
mkhashch_s_20130225_619.jpg

Levee Mile Report Line	27
Start Levee Mile	2.89
End Levee Mile	2.89
Location	Land Side
Category	
Item	Animal Control
11/02/2011 Numerous burrows on levee slope.	
mkhashch_s_20130225_620.jpg

Levee Mile Report Line	27
Start Levee Mile	2.89
End Levee Mile	2.89
Location	Land Side
Category	
Item	Animal Control
View of numerous rodent holes with bait stations present. 09/25/2012	
mkhashch_s_20130225_621.JPG

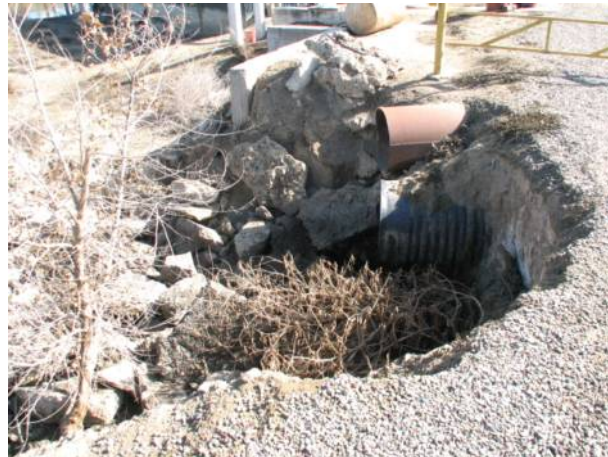
Levee Mile Report Line	28
Start Levee Mile	2.91
End Levee Mile	2.91
Location	Water Side
Category	
Item	Erosion / Bank Caving
Levee slope is being eroded at this location. Repair needed to preserve access road.	
mkhashch_s_20130225_622.jpg

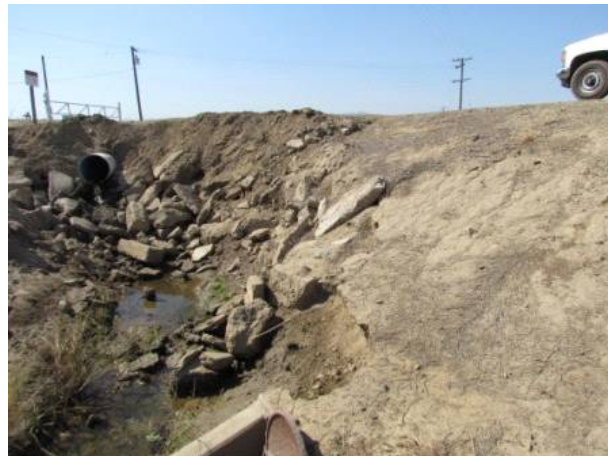
Levee Mile Report Line	28
Start Levee Mile	2.91
End Levee Mile	2.91
Location	Water Side
Category	
Item	Erosion / Bank Caving
View of repaired site, but it appears that erosion is still occurring. 09/25/2012	
mkhashch_s_20130225_623.JPG

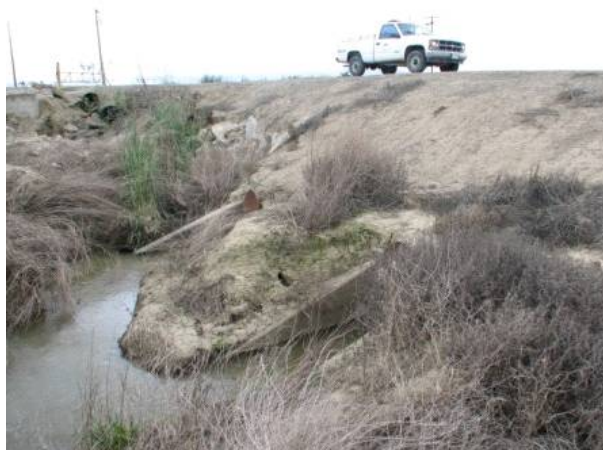
Levee Mile Report Line	29
Start Levee Mile	2.91
End Levee Mile	2.91
Location	Water Side
Category	
Item	Encroachments

Drainage discharge to San Joaquin River.

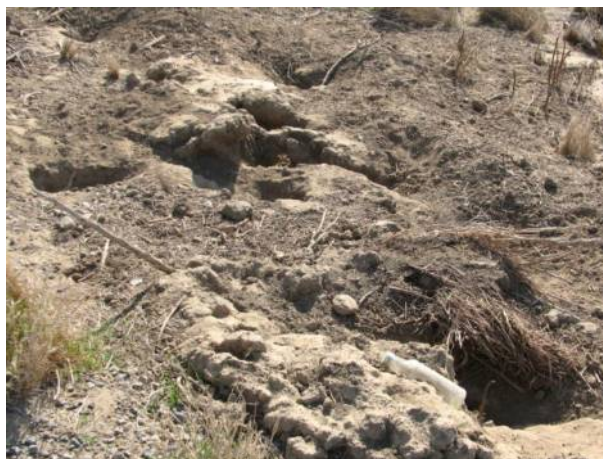
Levee Mile Report Line	30
Start Levee Mile	3.02
End Levee Mile	3.20
Location	Land Side
Category	
Item	Animal Control

11/02/2011 Numerous burrows present, some already caving in, others are active.

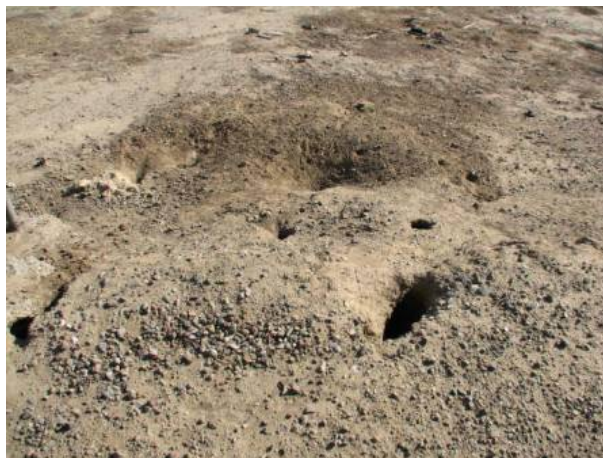
Levee Mile Report Line	30
Start Levee Mile	3.02
End Levee Mile	3.20
Location	Land Side
Category	
Item	Animal Control

11/02/2011 Many active burrows present.

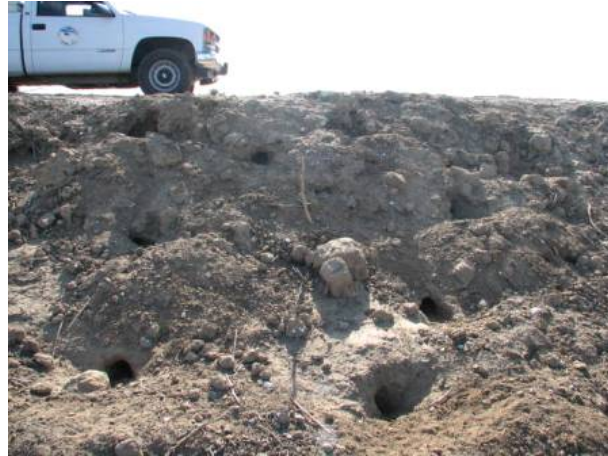
Levee Mile Report Line	30
Start Levee Mile	3.02
End Levee Mile	3.20
Location	Land Side
Category	
Item	Animal Control
11/02/2011 Many burrows present throughout the levee slope.	
mkhashch_s_20130225_607.jpg

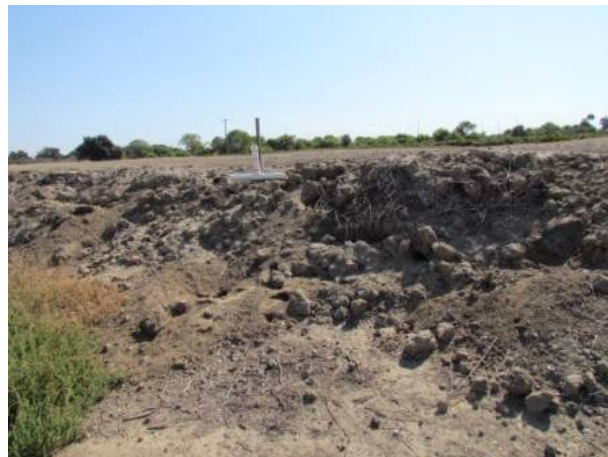
Levee Mile Report Line	30
Start Levee Mile	3.02
End Levee Mile	3.20
Location	Land Side
Category	
Item	Animal Control
View of the many rodent holes on landside slope. 09/25/2012	
mkhashch_s_20130225_608.JPG

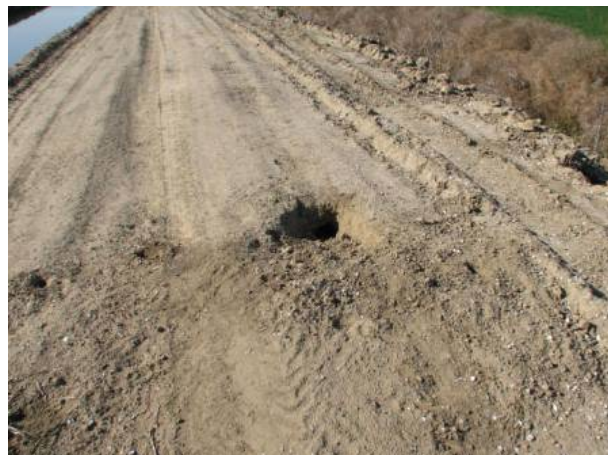
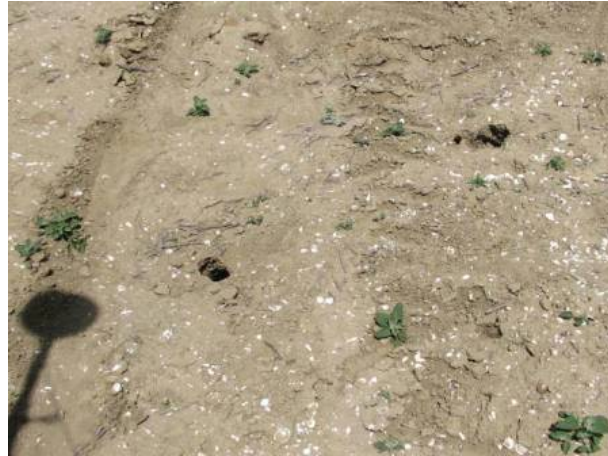
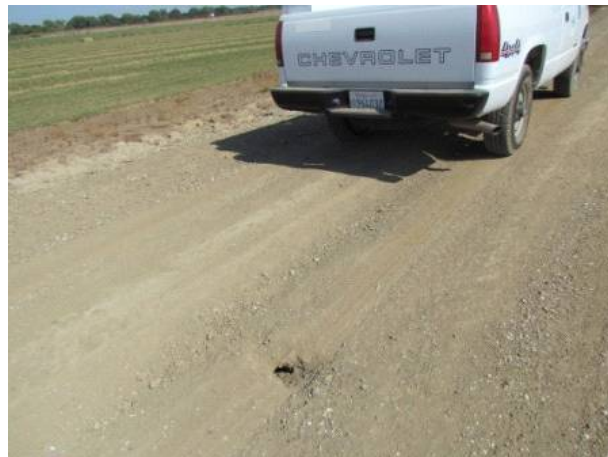
31	3.11	3.11		Animal Control	CR Ma	A3 : No rodents visible, but rodent burrows visible; need to backfill and compact or grout burrows. Inspector Comments: Large burrow in crown with no rodents present at time of inspection.	37.637943 ° -121.232620 °	37.637943 ° -121.232620 °	18 Y
DWR ID: DWR_RD2101_01_s_2012_18

Levee Mile Report Line	31
Start Levee Mile	3.11
End Levee Mile	3.11
Location	Crown
Category	
Item	Animal Control
11/02/2011 Large burrow in crown.	
mkhashch_s_20130225_609.jpg

Levee Mile Report Line	31
Start Levee Mile	3.11
End Levee Mile	3.11
Location	Crown
Category	
Item	Animal Control
05/02/2012 Rodent holes in the levee crown.	
mkhashch_s_20130225_610.jpg

Levee Mile Report Line	31
Start Levee Mile	3.11
End Levee Mile	3.11
Location	Crown
Category	
Item	Animal Control
View of the rodent hole in the levee crown. Smaller holes were covered due to crown regrading. 09/25/2012	
mkhashch_s_20130225_611.JPG

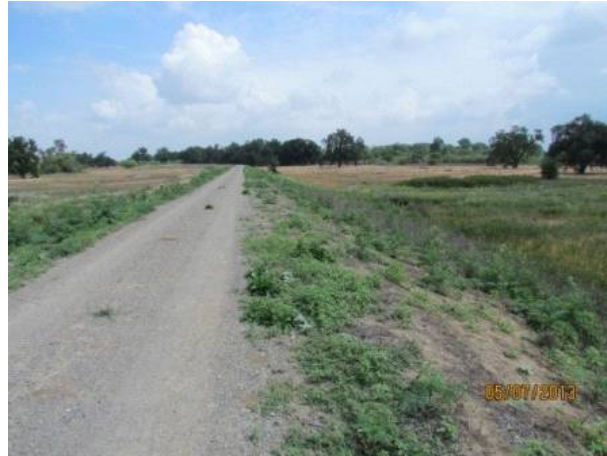
Levee Mile Report Line	1
Start Levee Mile	0.05
End Levee Mile	0.05
Location	Water Side
Category	
Item	Vegetation

LMR No.	Levee Mile		Category	Item	Location *	Rating ** +	Action/Comment	GPS Latitude/Longitude		Issue No. Photo
	Start	End						Start	End	
1	0.05	0.05		Vegetation	WS	M	V1 : Control annual grass and weeds on the levee slopes and easements.	37.660491 ° -121.243325 °	37.660491 ° -121.243325 °	1 Y

View of the vegetation on the waterside levee slope, facing downstream.
